DEPARTMENT OF NATURAL RESOURCES
DIVISION OF OIL, GAS AND MINING

RE: Site Inspection, H & H Stone, Holley Project, S/037/117, San Juan County, Utah

Date of Inspection: May 29, 2003
Time of Inspection: 2:30-3:15 p.m.
Conditions: Partly cloudy, 80's
Participants: Paul Baker (DOGM)

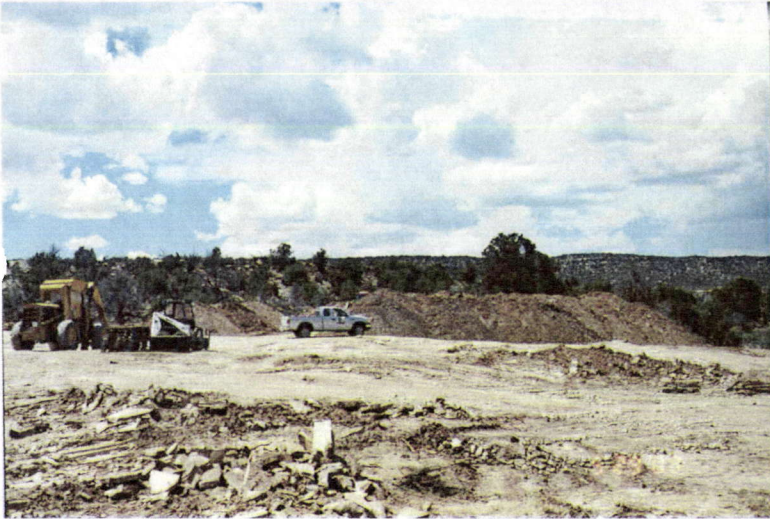
The quarry is in a shallow draw (Photo 4), and it appears there is less soil/overburden nearer the center of the drainage than in adjacent areas. The operator has pushed soil into berms around the quarry (Photos 1 and 2), particularly on the north side. Equipment on site included a front end loader, a forklift, and a Bobcat. There were about 20 pallets of stone.

I believe the material shown in Photo 2 is salvaged soil, but there is a large pile in Photos 1 and 3 that might be either soil or overburden.

Photo 1. Forklift and Bobcat on the left with a pile of overburden or soil near the center.

If the material in the large pile shown in Photos 1 and 3 is soil, it needs to be protected. Even if it is considered overburden, it would probably substitute as a soil since the parent material is sandstone.

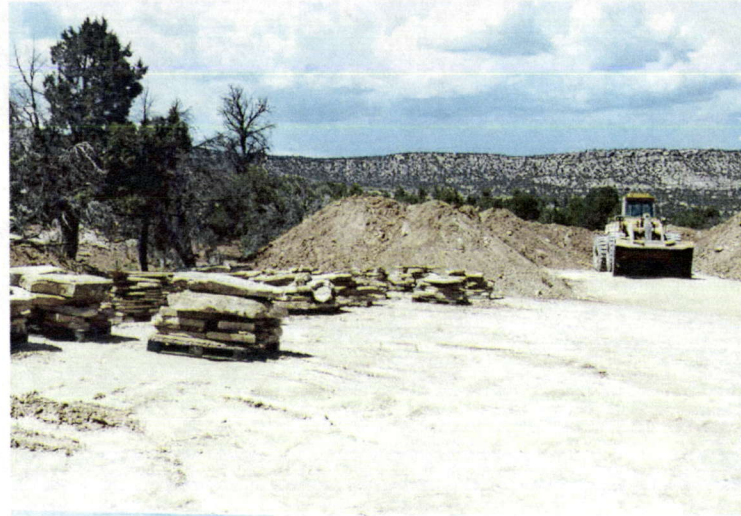
Photo 3. A front end loader with some pallets of stone.

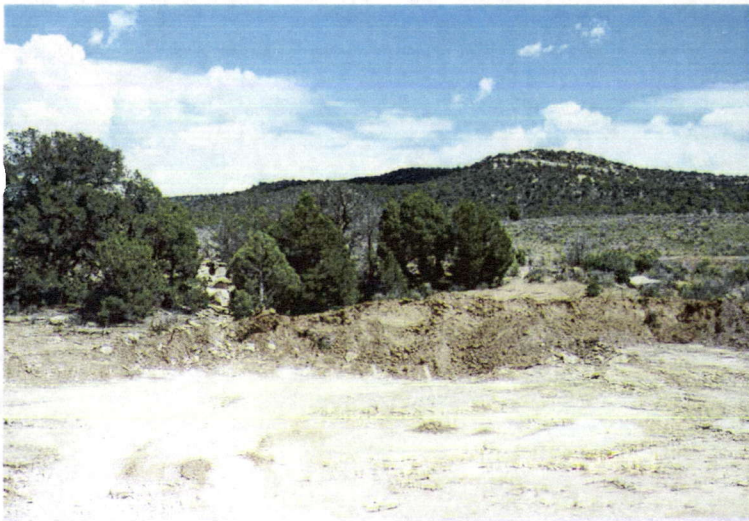
Photo 2. A soil berm.

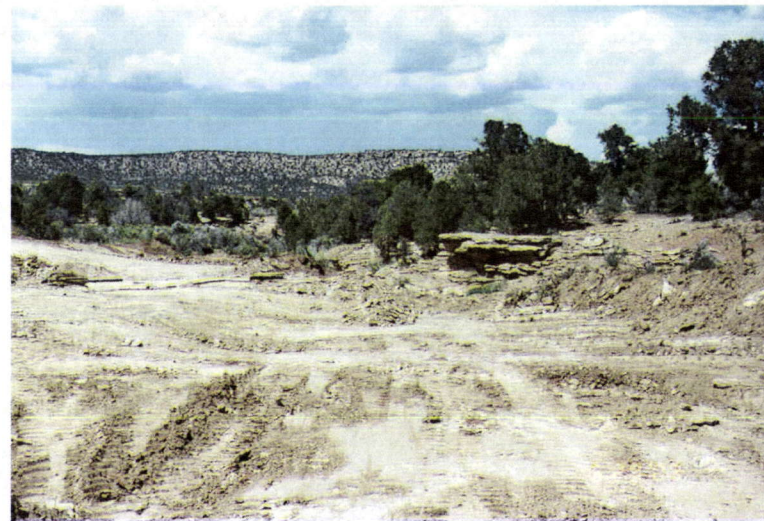
Photo 4. This photo was intended to show how the drainage goes through the quarry, but the drainage does not show up well because it is broad with a low gradient.

The draw in which the quarry is being operated is ephemeral, and although it does not appear there is often very much water in it, it would be fairly simple for the operator to install a silt fence or straw bales to reduce the amount of sediment leaving the mine. Straw bales would be installed across the drainage with stakes driven through them into the ground to hold them in place. A silt fence would be made from geotextile with the bottom buried a few inches below the surface and the top wired to some stakes.

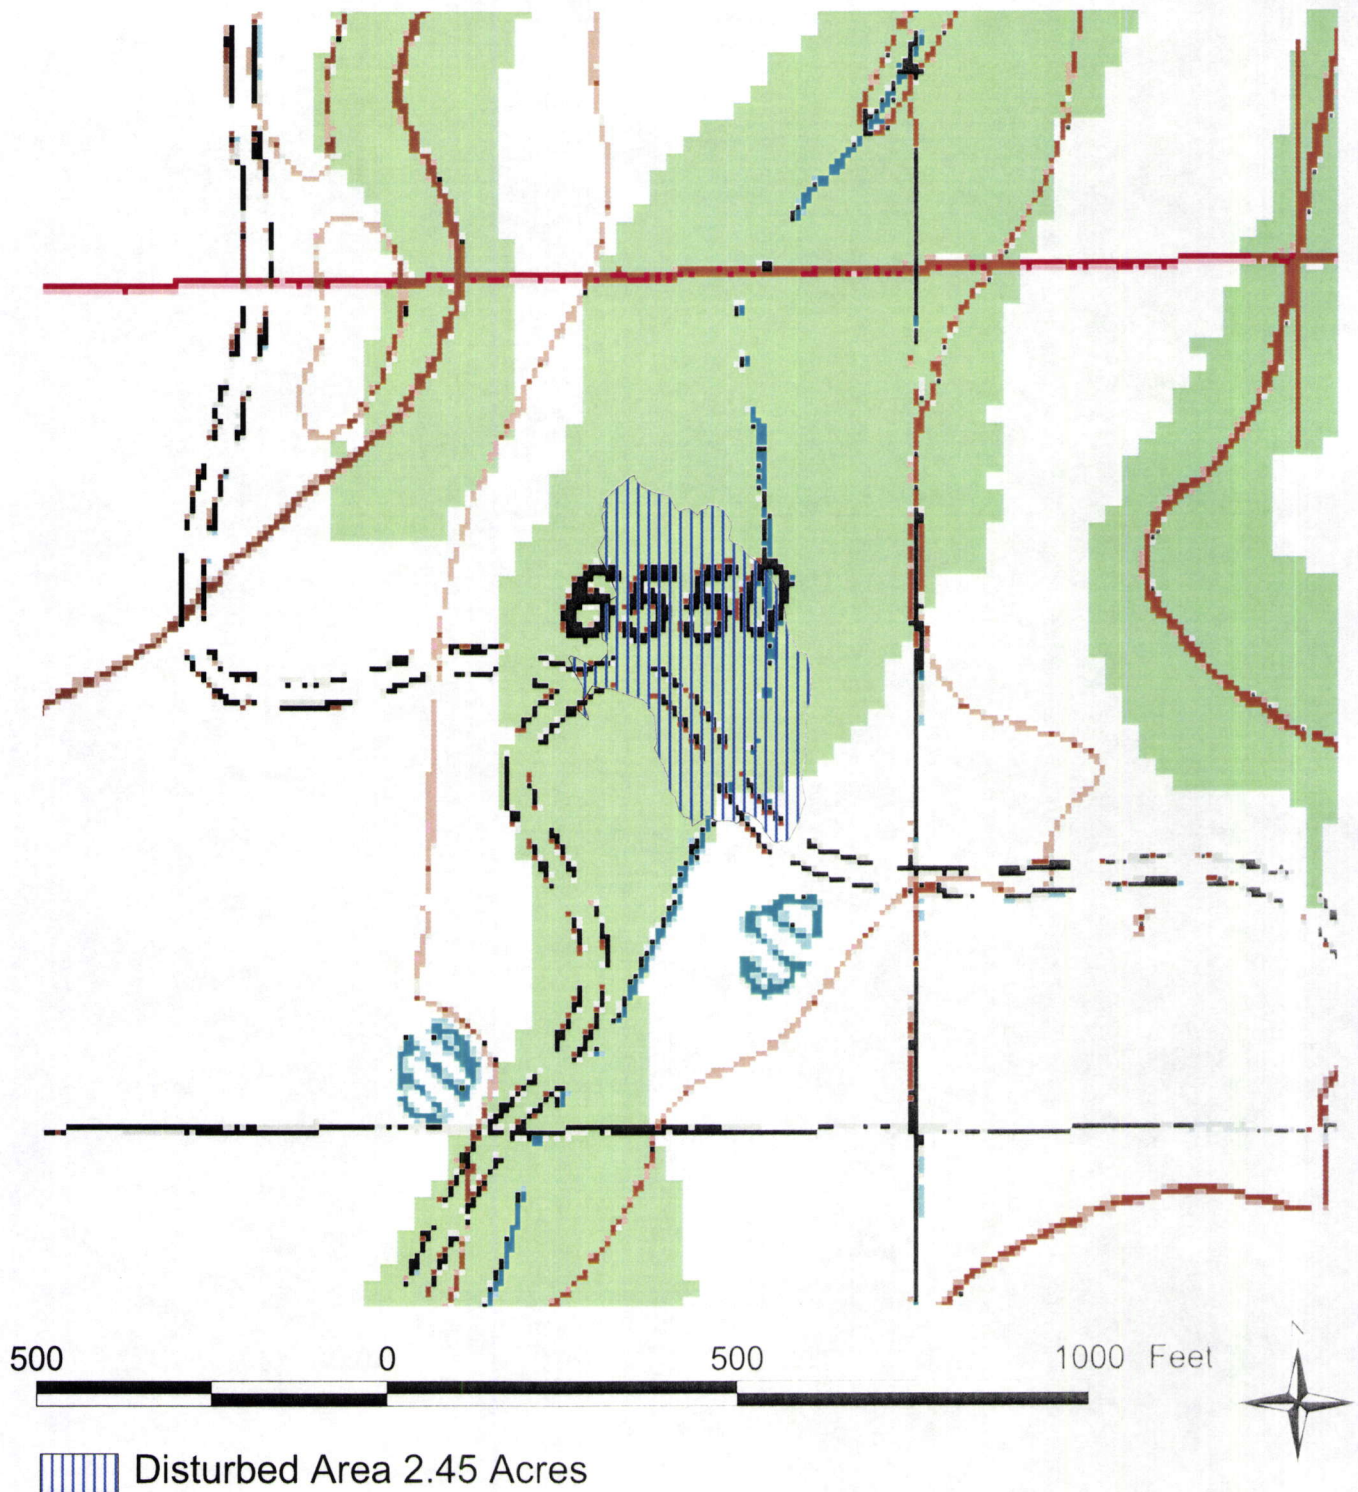
H & H Quarry S/037/117

I took global positioning system (GPS) readings of the site perimeter and from this created a map which is attached to this report. The disturbed area was 2.45 acres.

Map created June 12, 2003, by Paul Baker from GPS data gathered May 29, 2003.
Summit Point Quad, N1/2 NE 1/4 Section 32, Township 31 South, Range 26 East, SLBM.
